**Flood Control Project Maintenance
Levee Inspections**

Fall 2009 Levee Maintenance Deficiency Summary Report

San Joaquin River Basin

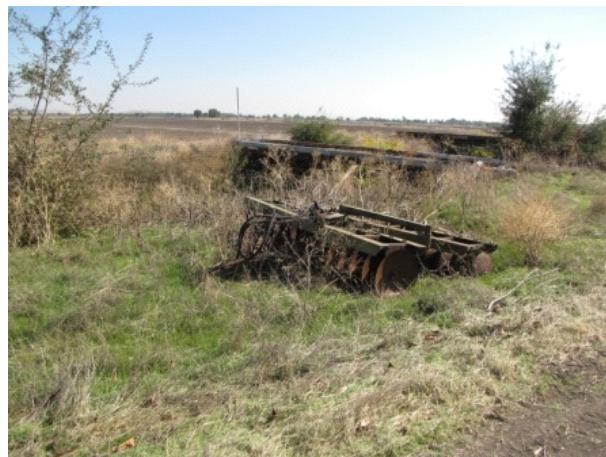
dpesaven_20091110_436.jpg

View of equipment on the waterward side of the levee looking upstream.

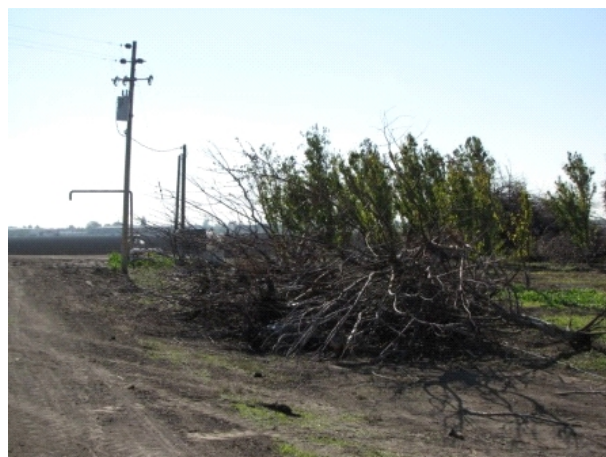
Levee Mile Report Line	3
Start Levee Mile	0.46
End Levee Mile	0.46
Location	Land Side
Category	Earthen Levee
Item	Encroachments

View of a prunings pile on the landward side of the levee looking upstream.

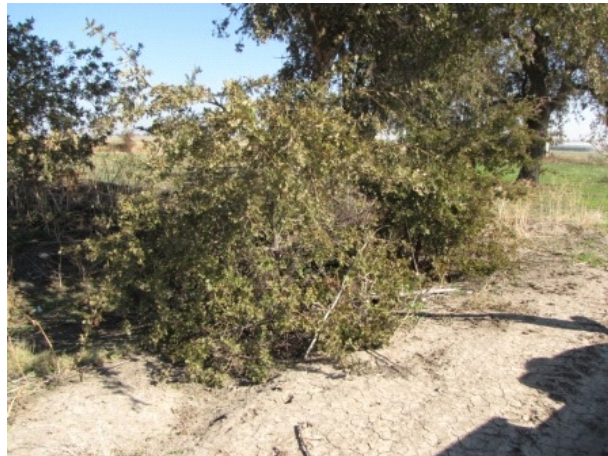
dpesaven_20091110_433.jpg

View of tree branches blocking visibility and access on the waterward side of the levee looking upstream.

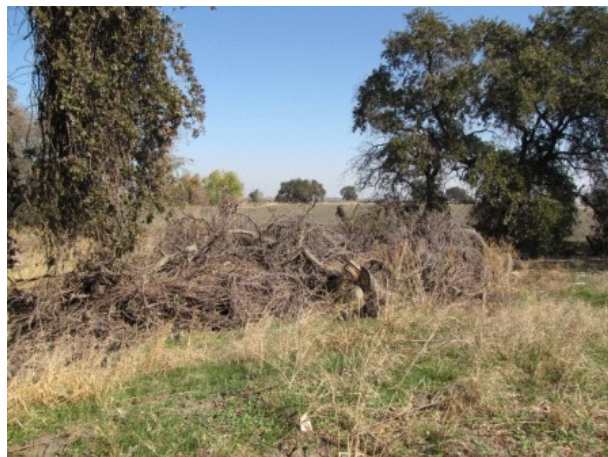
Levee Mile Report Line	6
Start Levee Mile	1.29
End Levee Mile	1.29
Location	Water Side
Category	Earthen Levee
Item	Encroachments

View of prunings on the waterward side of the levee blocking visibility and access.

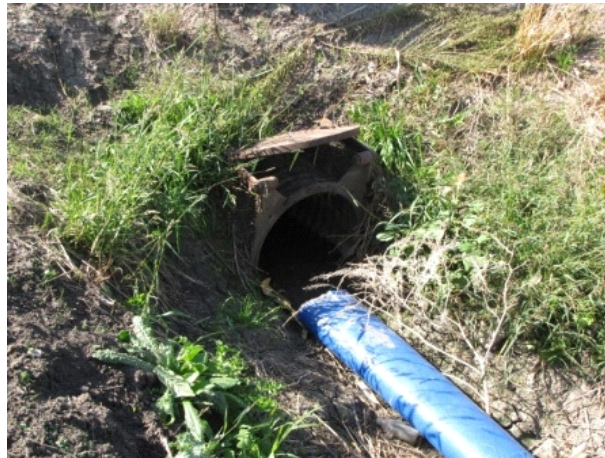
dpesaven_20091110_431.jpg

View of a blocked flap gate on the waterward side of the levee. Debris and sediment prevent this gate from closing.

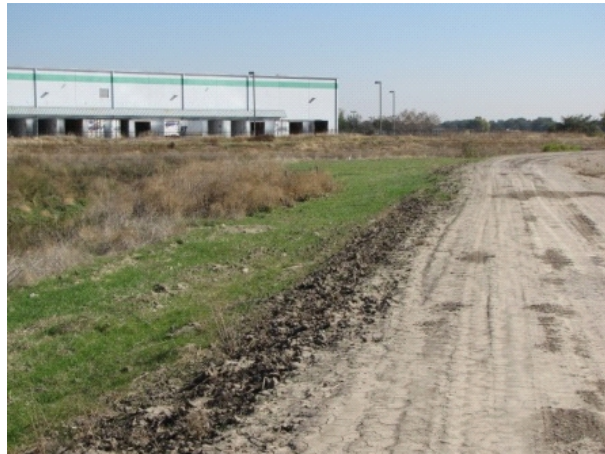
Levee Mile Report Line	8
Start Levee Mile	1.60
End Levee Mile	2.85
Location	Water Side
Category	Earthen Levee
Item	Slope Stability

View of the waterward side of the levee looking upstream where the farmer has disked the slope of the levee.

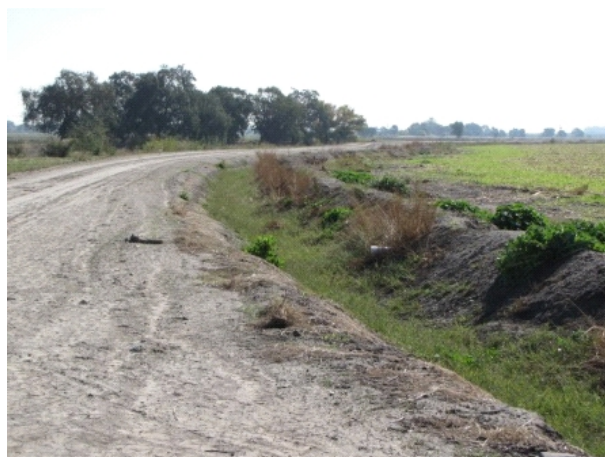
Levee Mile Report Line	9
Start Levee Mile	1.60
End Levee Mile	2.25
Location	Land Side
Category	Earthen Levee
Item	Encroachments

View of an agricultural ditch on the landward side of the levee looking upstream.

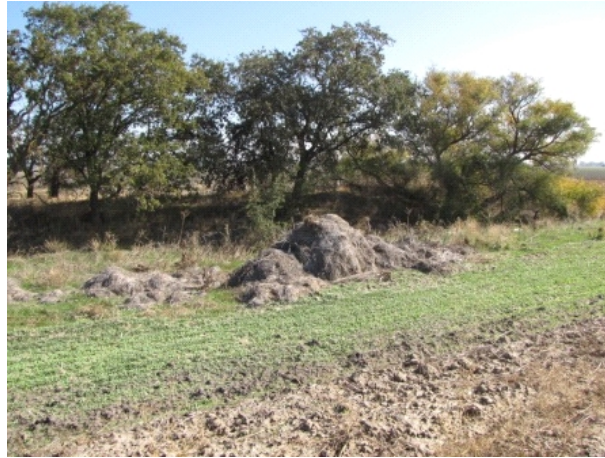
dpesaven_20091110_430.jpg

View of debris on the waterward side of the levee.

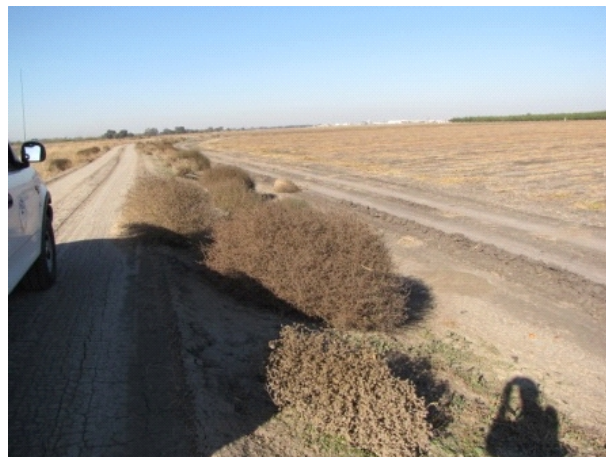
dpesaven_20091110_439.jpg

View of excessive vegetation blocking visibility and access along the landward slope looking downstream.

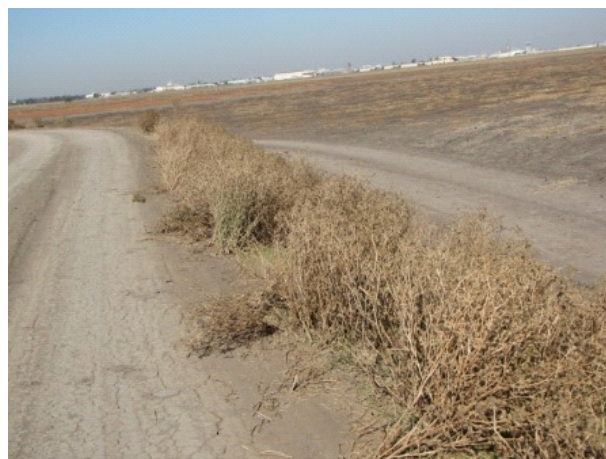
Levee Mile Report Line	3
Start Levee Mile	0.44
End Levee Mile	0.46
Location	Land Side
Category	Earthen Levee
Item	Vegetation

View of excessive vegetation blocking visibility and access along the landward slope looking downstream.

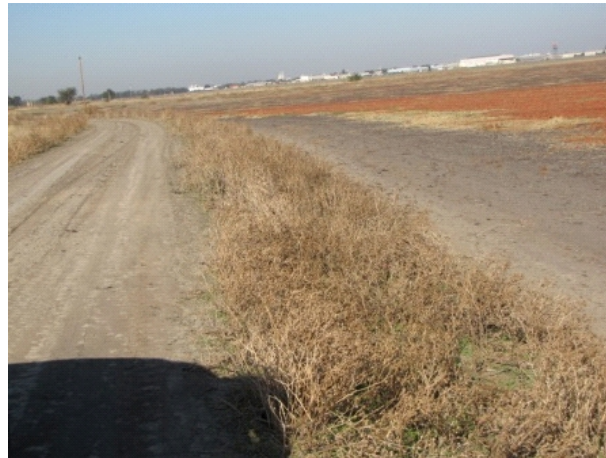
dpesaven_20091110_441.jpg

View of excessive vegetation blocking visibility and access along the landward slope looking downstream.

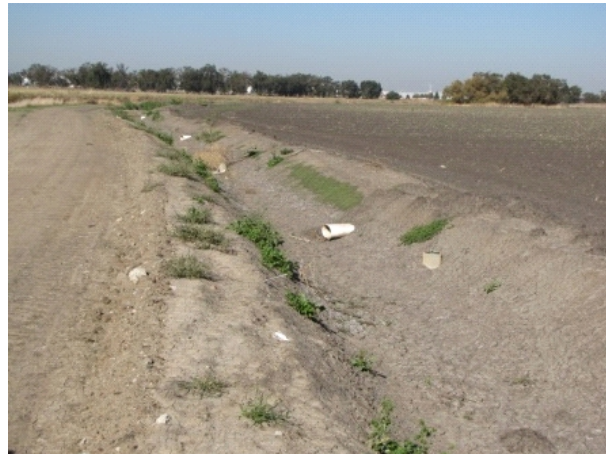
Levee Mile Report Line	7
Start Levee Mile	1.92
End Levee Mile	2.21
Location	Land Side
Category	Earthen Levee
Item	Encroachments

View of an agricultural ditch on the landward side of the levee looking downstream.

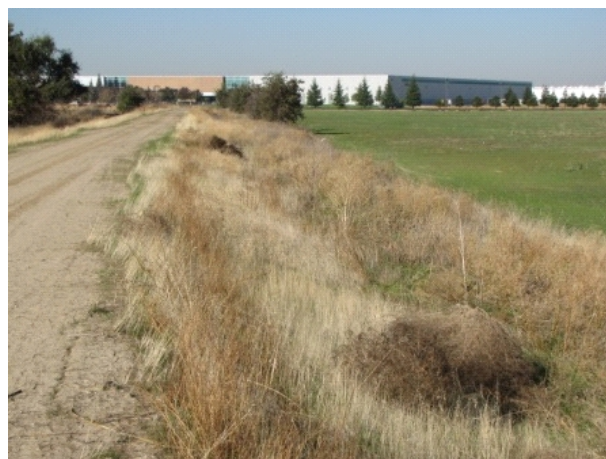
Levee Mile Report Line	8
Start Levee Mile	2.59
End Levee Mile	3.10
Location	Land Side
Category	Earthen Levee
Item	Vegetation

View of excessive vegetation blocking visibility and access along the landward slope looking downstream.

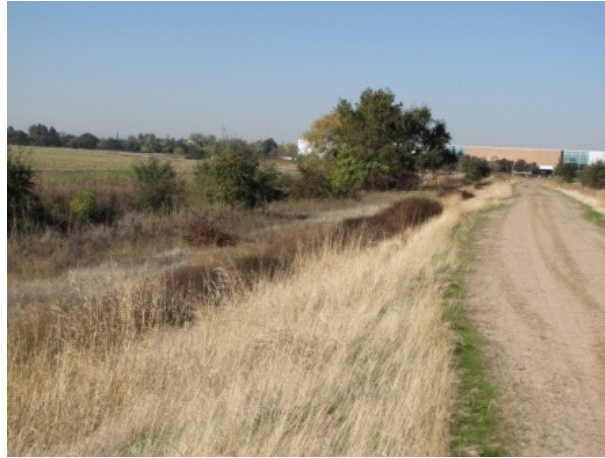
dpesaven_20091110_442.jpg

View of excessive vegetation blocking visibility and access along the waterward slope looking downstream.

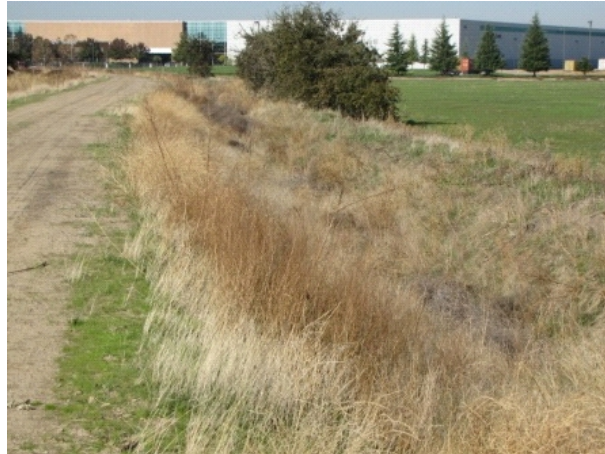
Levee Mile Report Line	10
Start Levee Mile	2.66
End Levee Mile	3.17
Location	Land Side
Category	Earthen Levee
Item	Encroachments

View of an agricultural ditch on the landward side of the levee looking downstream.

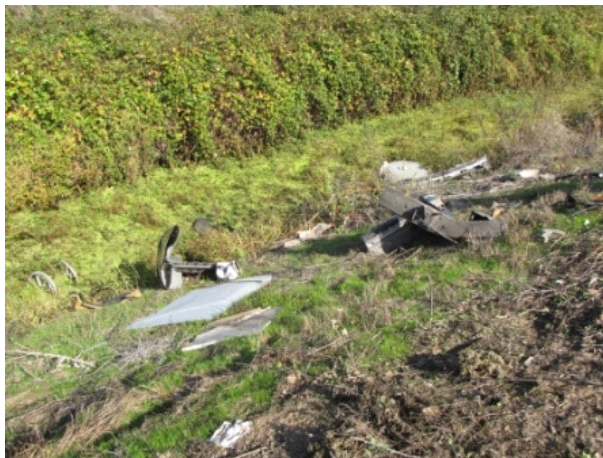
dpesaven_20091028_326.jpg

View of debris recently tossed into the channel and onto the waterward levee slope.

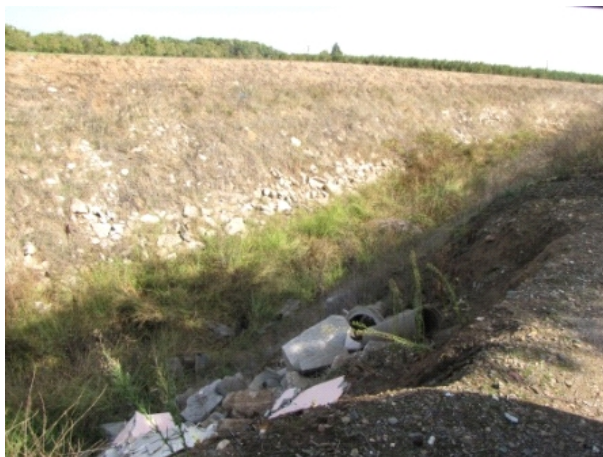
dpesaven_20091028_325.jpg

View of erosion significantly encroaching into the levee and access road looking upstream. Debris should be removed and a proper repair should be done.

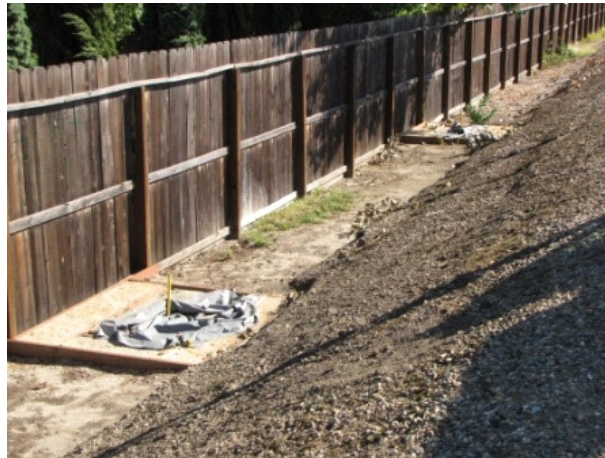
dpesaven_20091102_330.jpg

View of unauthorized horseshoe pits along the landward toe looking upstream.

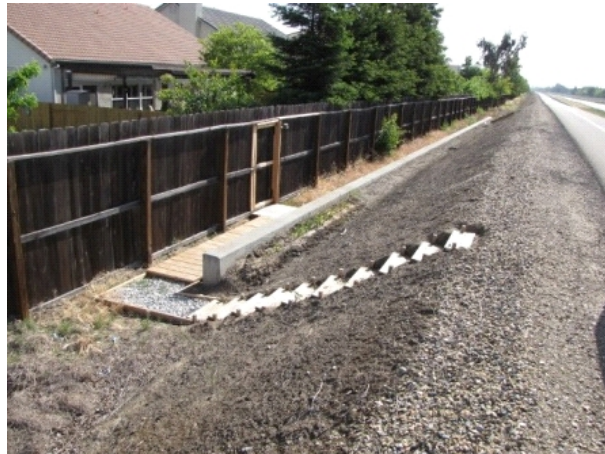
Levee Mile Report Line	2
Start Levee Mile	0.81
End Levee Mile	0.81
Location	Land Side
Category	Earthen Levee
Item	Encroachments

Stairs dug into levee slope. Remove the steps and recompact the levee slope.

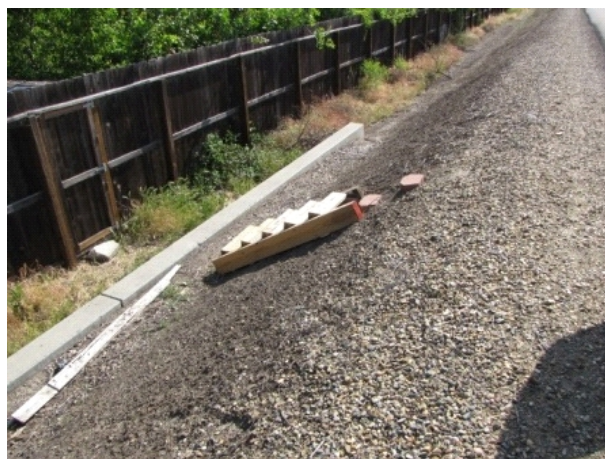
Levee Mile Report Line	3
Start Levee Mile	0.83
End Levee Mile	0.83
Location	Land Side
Category	Earthen Levee
Item	Encroachments

Stairs on landward slope of levee.

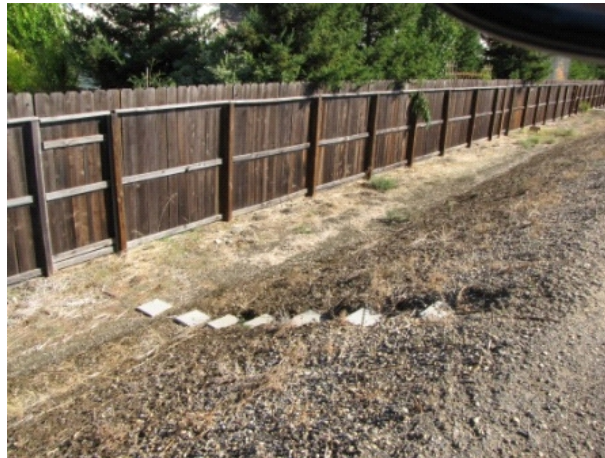
dpesaven_20091102_331.jpg

View of unauthorized steps dug into the landward slope looking upstream.

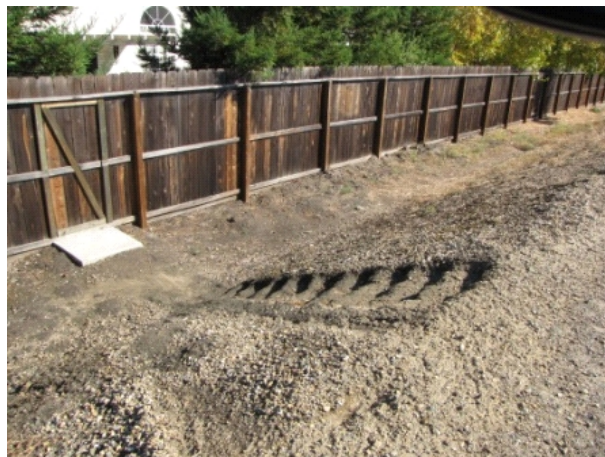
Levee Mile Report Line	6
Start Levee Mile	0.97
End Levee Mile	0.97
Location	Land Side
Category	Earthen Levee
Item	Encroachments

View of unauthorized steps dug into the landward slope looking upstream.

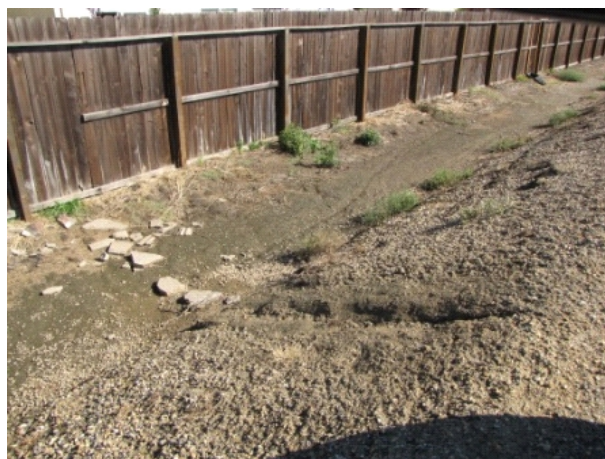
Levee Mile Report Line	8
Start Levee Mile	1.11
End Levee Mile	1.11
Location	Land Side
Category	Earthen Levee
Item	Encroachments

View of unauthorized steps dug into the landward slope looking upstream.

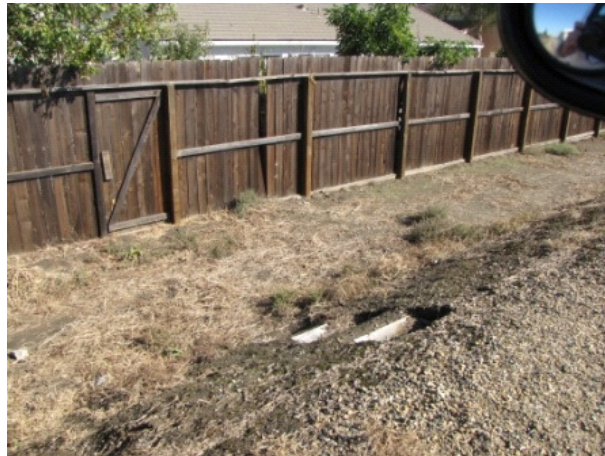
dpesaven_20091102_334.jpg

View of unauthorized steps dug into the landward slope looking upstream.

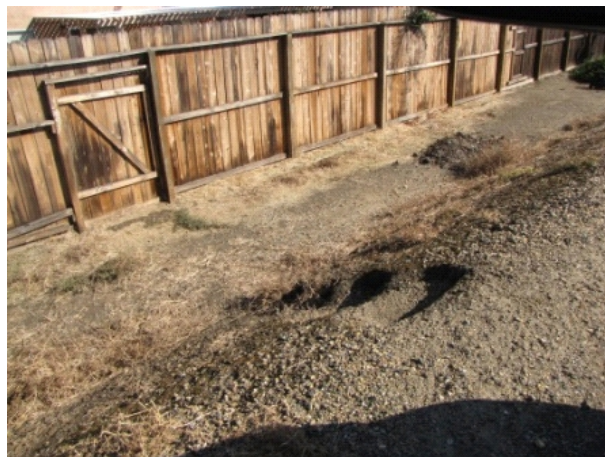
Levee Mile Report Line	11
Start Levee Mile	1.16
End Levee Mile	1.16
Location	Land Side
Category	Earthen Levee
Item	Encroachments

View of unauthorized steps dug into the landward slope looking upstream.

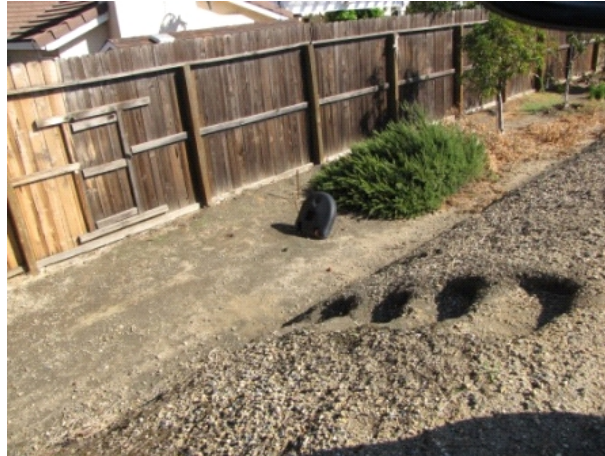
dpesaven_20091102_336.jpg

View of unauthorized steps dug into the landward slope looking upstream.

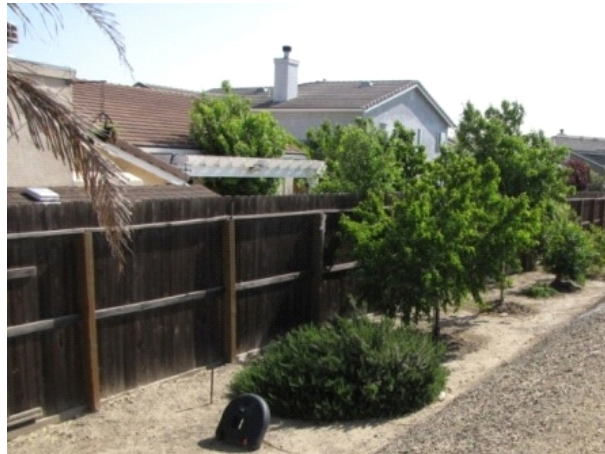
Levee Mile Report Line	13
Start Levee Mile	1.18
End Levee Mile	1.18
Location	Land Side
Category	Earthen Levee
Item	Encroachments

Landscaping within 10' of landward toe of levee.

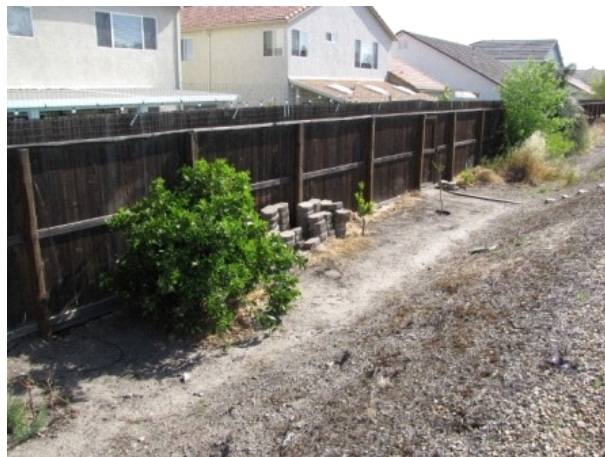
Levee Mile Report Line	14
Start Levee Mile	1.39
End Levee Mile	1.39
Location	Land Side
Category	Earthen Levee
Item	Encroachments

Landscaping within 10' of toe of levee.

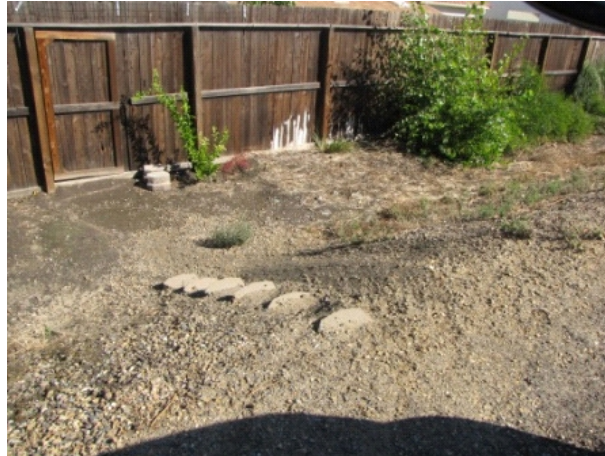
dpesaven_20091102_337.jpg

View of unauthorized steps dug into the landward slope looking upstream.

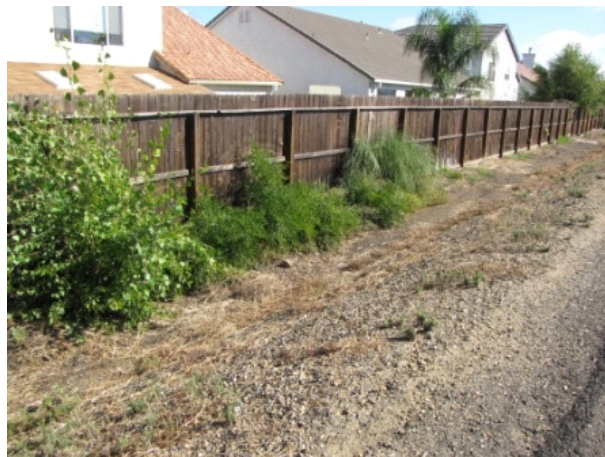
Levee Mile Report Line	16
Start Levee Mile	1.40
End Levee Mile	1.40
Location	Land Side
Category	Earthen Levee
Item	Encroachments

View of landscaping along the landward toe looking upstream.

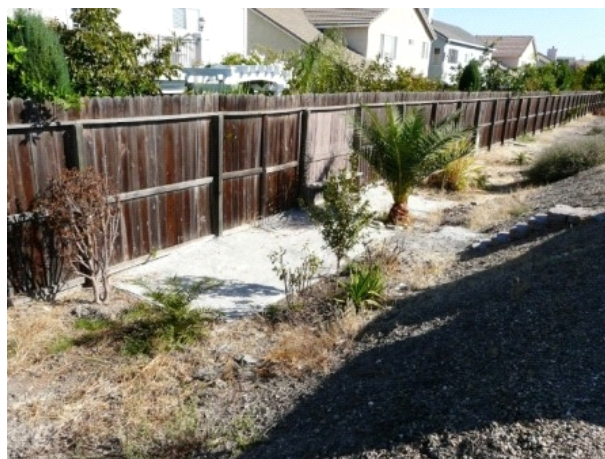
Levee Mile Report Line	17
Start Levee Mile	1.45
End Levee Mile	1.45
Location	Land Side
Category	Earthen Levee
Item	Encroachments

Landscaping located within 10' from landside toe of levee at LM 1.45.

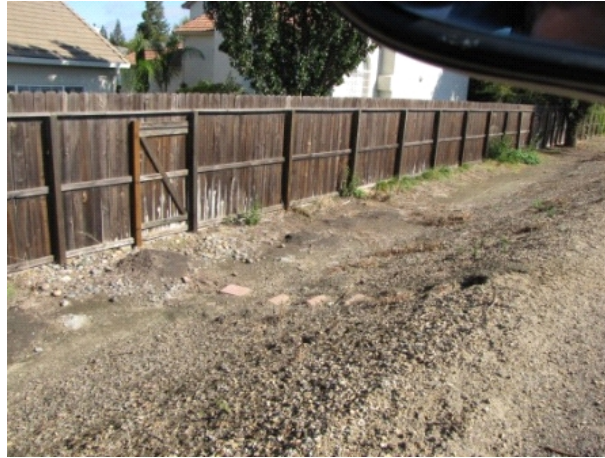
dpesaven_20091102_339.jpg

View of unauthorized steps dug into the landward slope looking upstream.

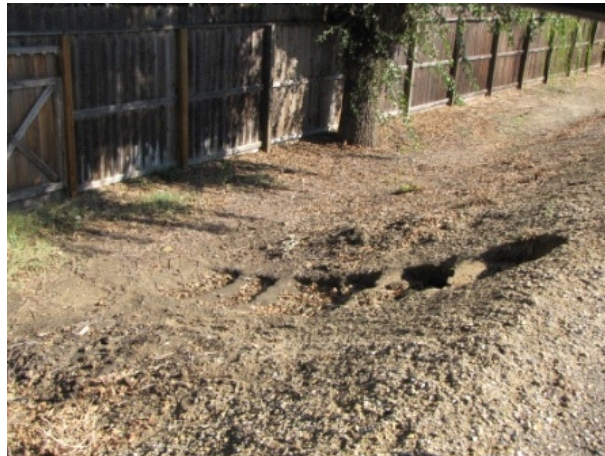
Levee Mile Report Line	19
Start Levee Mile	1.54
End Levee Mile	1.54
Location	Land Side
Category	Earthen Levee
Item	Encroachments

View of unauthorized steps dug into the landward slope looking upstream.

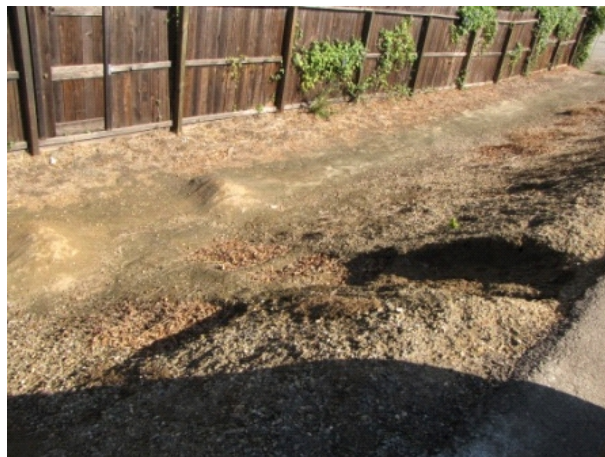
Levee Mile Report Line	20
Start Levee Mile	1.55
End Levee Mile	1.55
Location	Land Side
Category	Earthen Levee
Item	Slope Stability

View of unauthorized steps dug into the landward slope looking upstream.

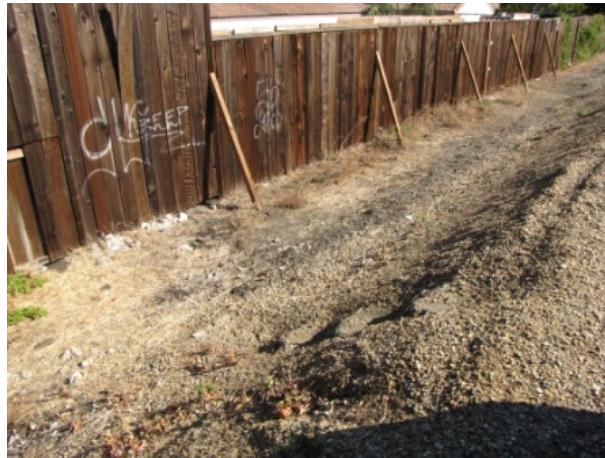
dpesaven_20091102_342.jpg

View of unauthorized steps dug into the landward slope looking upstream.

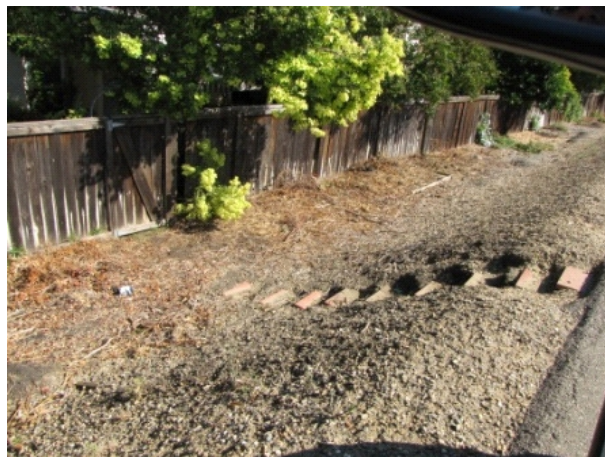
Levee Mile Report Line	23
Start Levee Mile	1.80
End Levee Mile	1.80
Location	Land Side
Category	Earthen Levee
Item	Encroachments

View of unauthorized steps dug into the landward slope looking upstream.

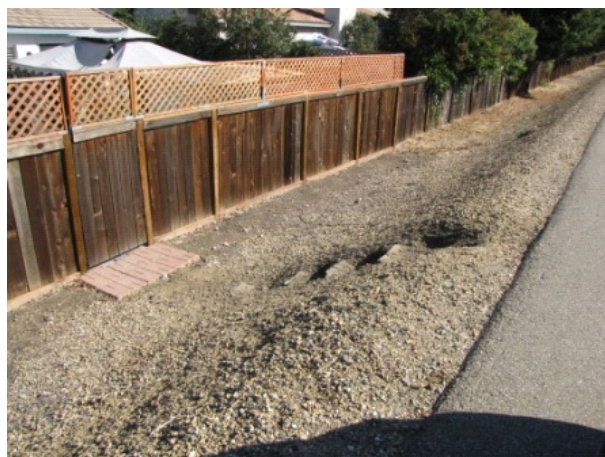
Levee Mile Report Line	24
Start Levee Mile	1.84
End Levee Mile	1.84
Location	Land Side
Category	Earthen Levee
Item	Encroachments

View of unauthorized steps dug into the landward slope looking upstream.

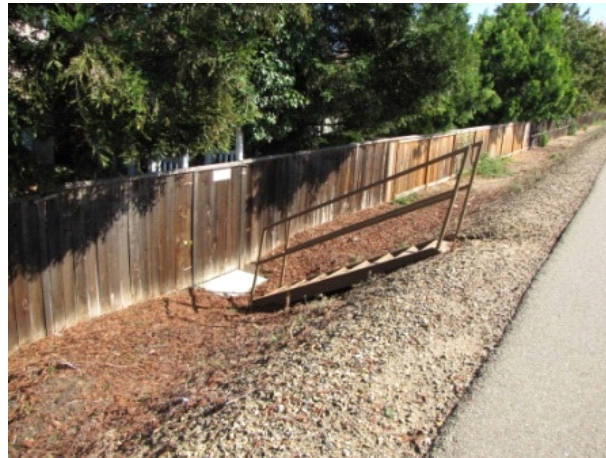
dpesaven_20091102_345.jpg

View of unauthorized steps dug into the landward slope looking upstream.

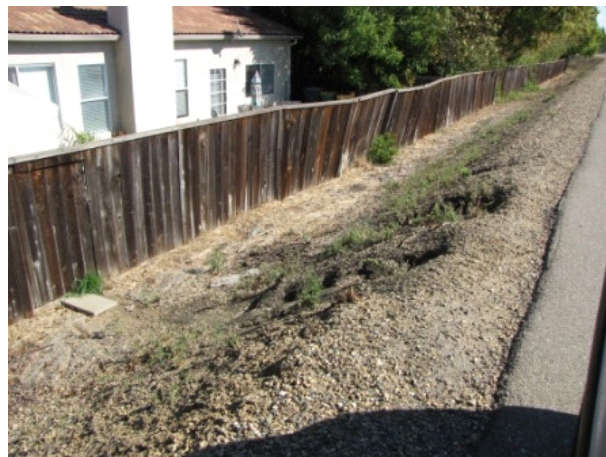
Levee Mile Report Line	26
Start Levee Mile	1.94
End Levee Mile	1.94
Location	Land Side
Category	Earthen Levee
Item	Encroachments

View of unauthorized steps dug into the landward slope looking upstream.

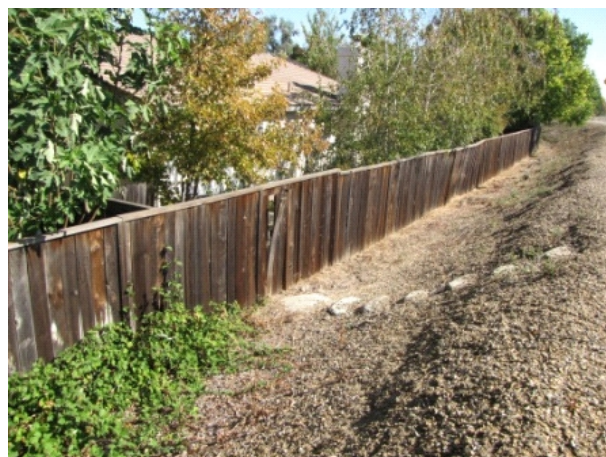
Levee Mile Report Line	27
Start Levee Mile	1.97
End Levee Mile	1.97
Location	Land Side
Category	Earthen Levee
Item	Encroachments

View of unauthorized steps dug into the landward slope looking upstream.

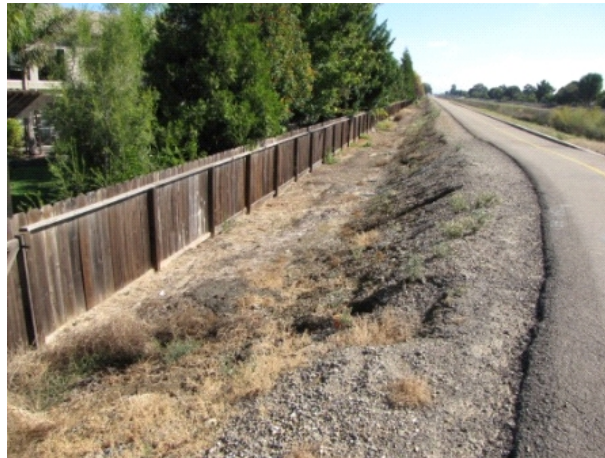
dpesaven_20091102_348.jpg

View of unauthorized steps dug into the landward slope looking upstream.

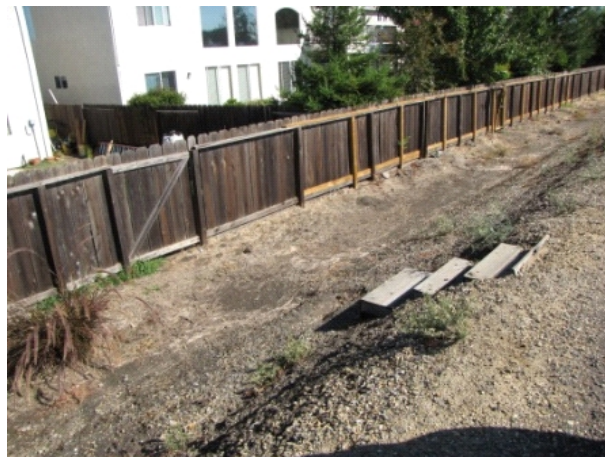
dpesaven_20091102_349.jpg

Levee Mile Report Line	29
Start Levee Mile	2.06
End Levee Mile	2.06
Location	Land Side
Category	Earthen Levee
Item	Encroachments

View of unauthorized steps dug into the landward slope looking upstream.

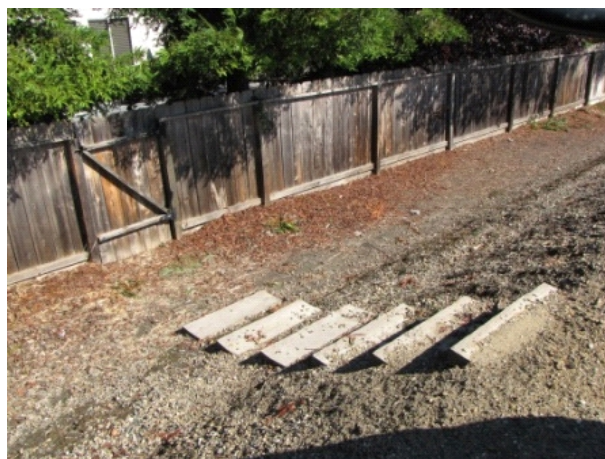
dpesaven_20091102_350.jpg

Levee Mile Report Line	30
Start Levee Mile	2.09
End Levee Mile	2.09
Location	Land Side
Category	Earthen Levee
Item	Encroachments

View of unauthorized steps dug into the landward slope looking upstream.

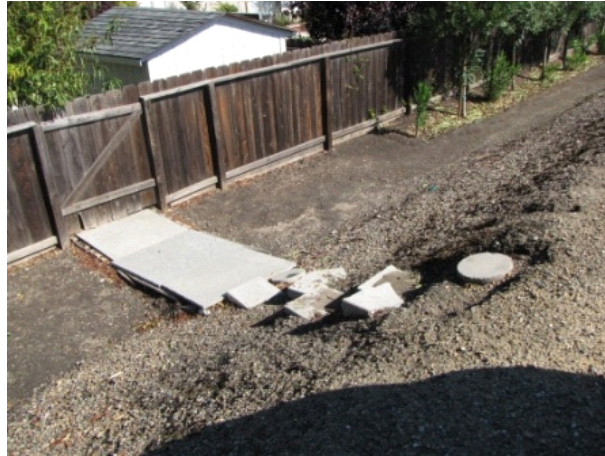
dpesaven_20091102_351.jpg

View of unauthorized steps dug into the landward slope looking upstream.

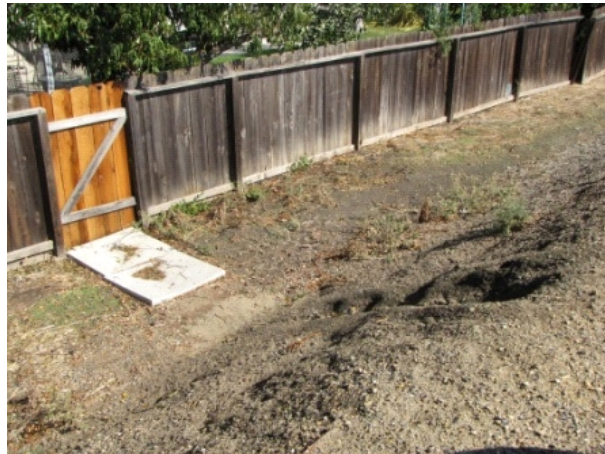
dpesaven_20091102_352.jpg

Levee Mile Report Line	32
Start Levee Mile	2.15
End Levee Mile	2.15
Location	Land Side
Category	Earthen Levee
Item	Encroachments

View of unauthorized steps dug into the landward slope looking upstream.

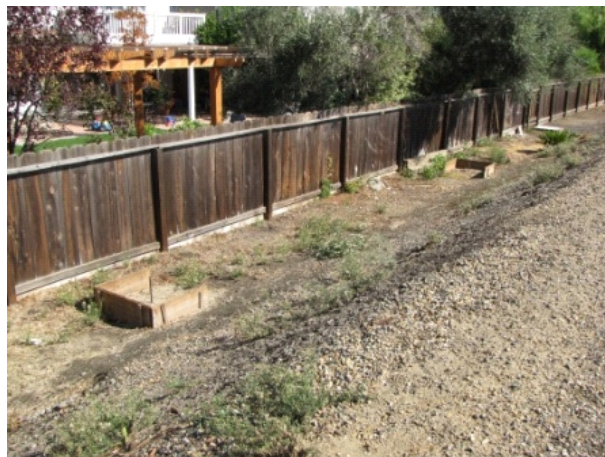
dpesaven_20091102_353.jpg

Levee Mile Report Line	33
Start Levee Mile	2.16
End Levee Mile	2.16
Location	Land Side
Category	Earthen Levee
Item	Encroachments

View of horseshoe pits along the landward toe looking upstream.

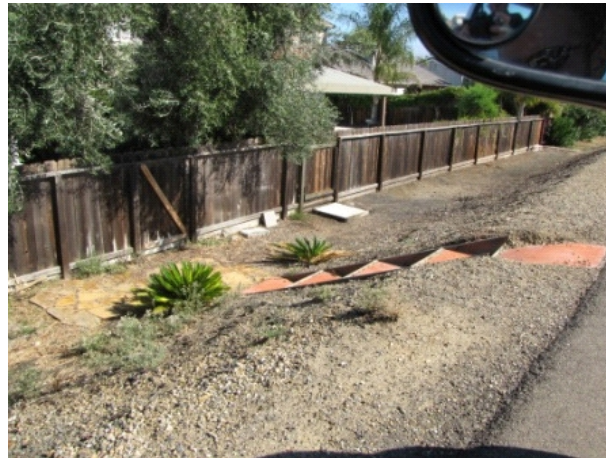
dpesaven_20091102_354.jpg

View of unauthorized steps dug into the landward slope looking upstream.

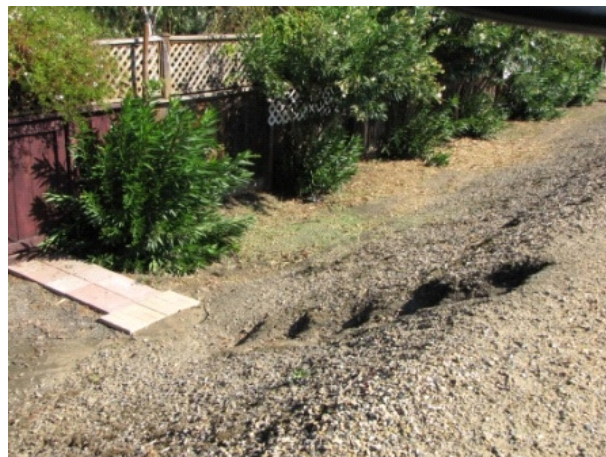
dpesaven_20091102_355.jpg

Levee Mile Report Line	35
Start Levee Mile	2.18
End Levee Mile	2.18
Location	Land Side
Category	Earthen Levee
Item	Encroachments

View of unauthorized steps dug into the landward slope looking upstream.

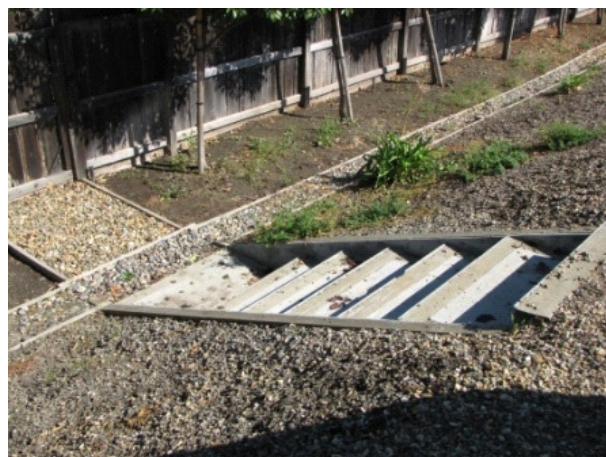
dpesaven_20091102_356.jpg

Levee Mile Report Line	36
Start Levee Mile	2.20
End Levee Mile	2.20
Location	Land Side
Category	Earthen Levee
Item	Encroachments

View of unauthorized steps dug into the landward slope looking upstream.

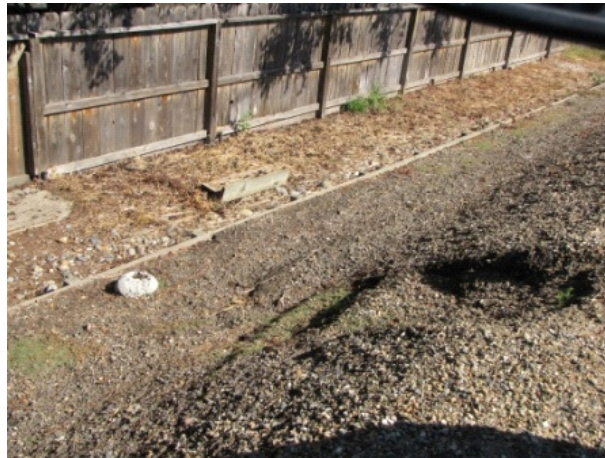
dpesaven_20091102_357.jpg

View of unauthorized steps dug into the landward slope looking upstream.

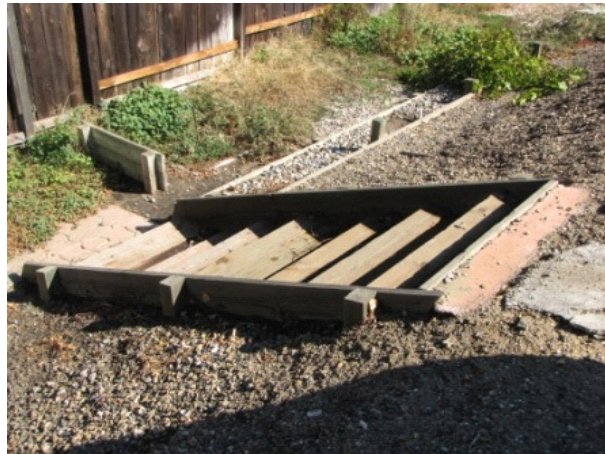
dpesaven_20091102_358.jpg

Levee Mile Report Line	38
Start Levee Mile	2.22
End Levee Mile	2.22
Location	Land Side
Category	Earthen Levee
Item	Encroachments

View of unauthorized steps dug into the landward slope looking upstream.

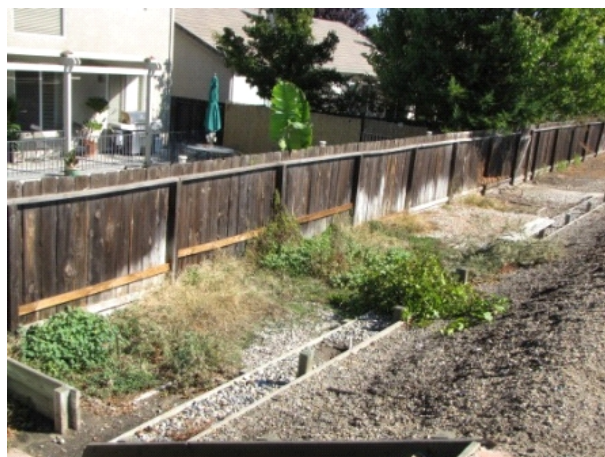
dpesaven_20091102_359.jpg

Levee Mile Report Line	39
Start Levee Mile	2.23
End Levee Mile	2.23
Location	Land Side
Category	Earthen Levee
Item	Encroachments

View of horseshoe pits and landscaping along the landward toe looking upstream.

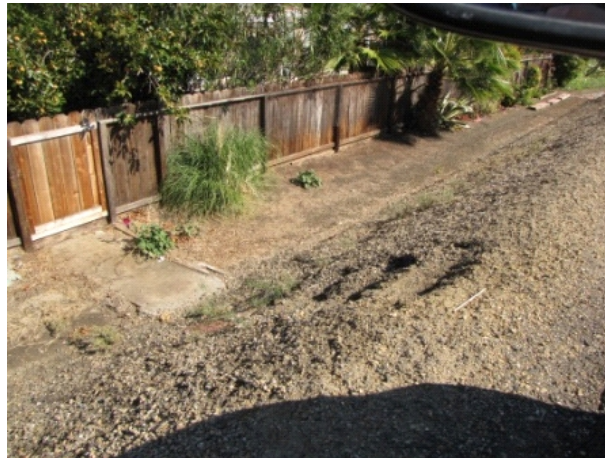
dpesaven_20091102_360.jpg

View of unauthorized steps dug into the landward slope looking upstream.

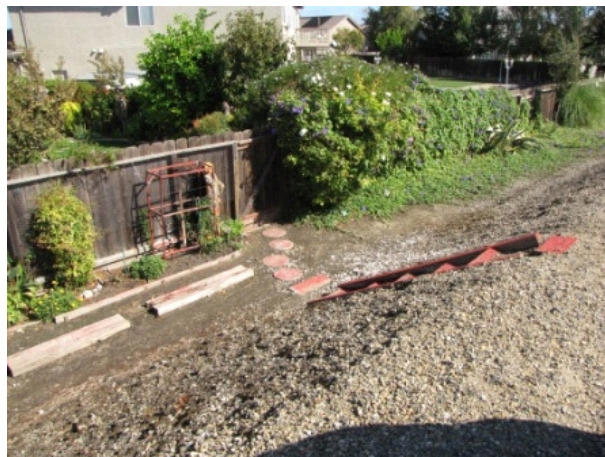
dpesaven_20091102_361.jpg

Levee Mile Report Line	41
Start Levee Mile	2.28
End Levee Mile	2.28
Location	Land Side
Category	Earthen Levee
Item	Encroachments

View of unauthorized steps dug into the landward slope and other landscaping looking upstream.

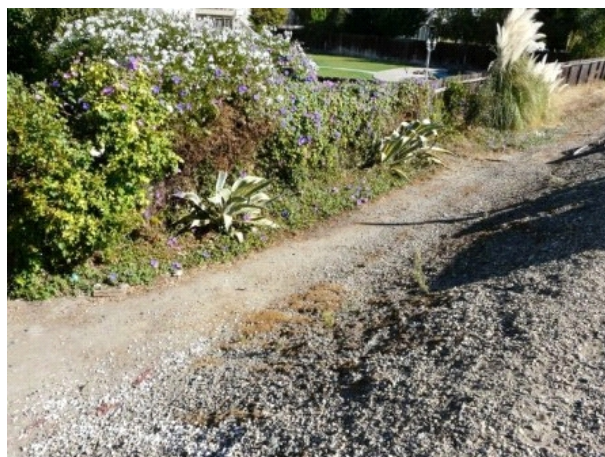
dpesaven_20091002_47.JPG

Levee Mile Report Line	42
Start Levee Mile	2.28
End Levee Mile	2.28
Location	Land Side
Category	Earthen Levee
Item	Encroachments

Landscaping located within 10' of landside toe of levee at LM 2.28.

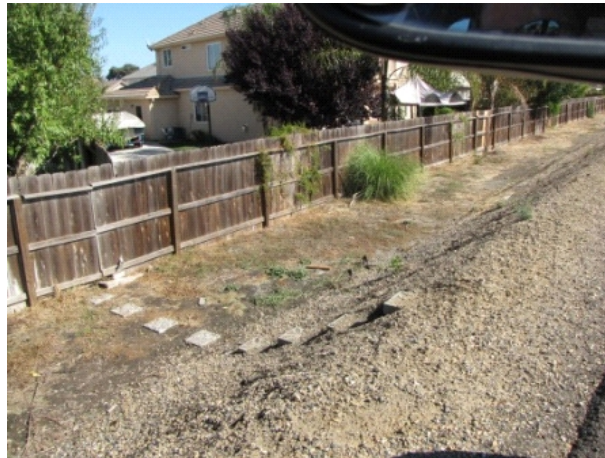
dpesaven_20091102_362.jpg

View of unauthorized steps dug into the landward slope looking upstream.

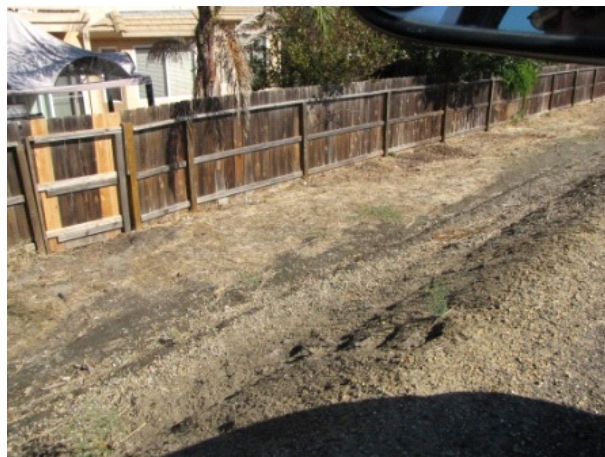
dpesaven_20091102_363.jpg

Levee Mile Report Line	44
Start Levee Mile	2.34
End Levee Mile	2.34
Location	Land Side
Category	Earthen Levee
Item	Encroachments

View of unauthorized steps dug into the landward slope looking upstream.

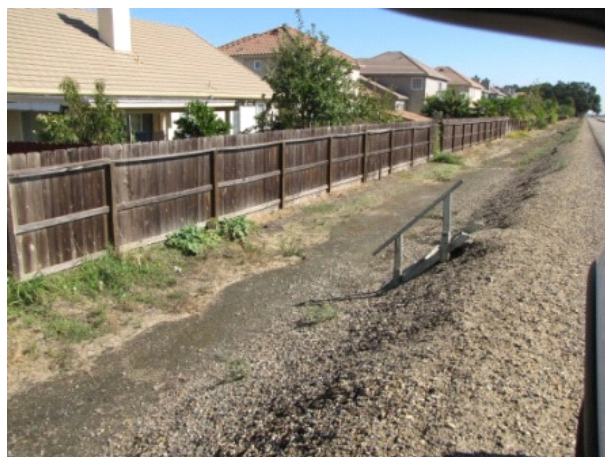
dpesaven_20091102_364.jpg

Levee Mile Report Line	45
Start Levee Mile	2.38
End Levee Mile	2.38
Location	Land Side
Category	Earthen Levee
Item	Encroachments

View of unauthorized steps dug into the landward slope looking upstream.

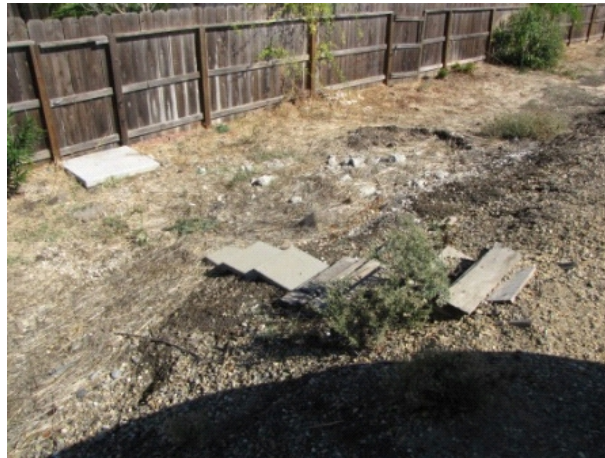
dpesaven_20091102_365.jpg

View of unauthorized steps dug into the landward slope looking upstream.

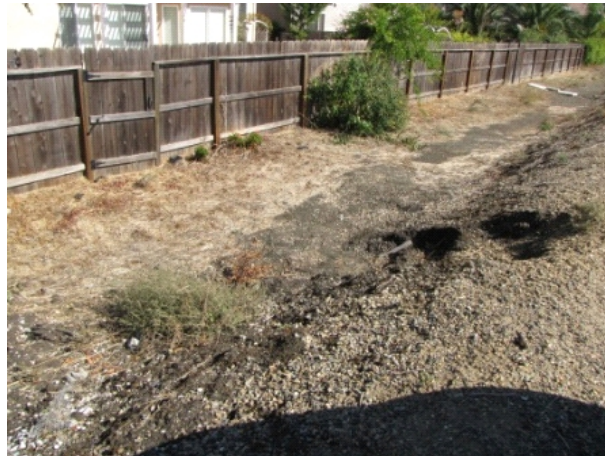
dpesaven_20091102_366.jpg

Levee Mile Report Line	47
Start Levee Mile	2.41
End Levee Mile	2.41
Location	Land Side
Category	Earthen Levee
Item	Encroachments

View of unauthorized steps dug into the landward slope looking upstream.

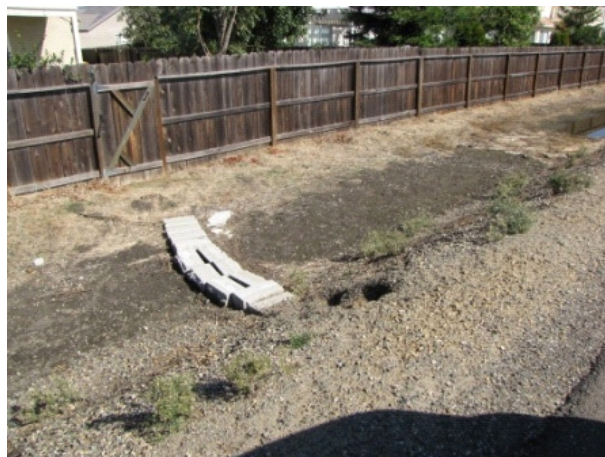
dpesaven_20091102_367.jpg

Levee Mile Report Line	48
Start Levee Mile	2.46
End Levee Mile	2.46
Location	Land Side
Category	Earthen Levee
Item	Encroachments

View of unauthorized steps dug into the landward slope looking upstream.

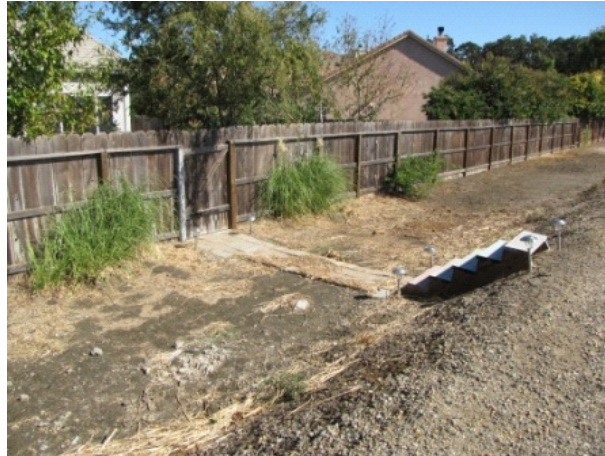
dpesaven_20091102_368.jpg

View of unauthorized steps dug into the landward slope looking upstream.

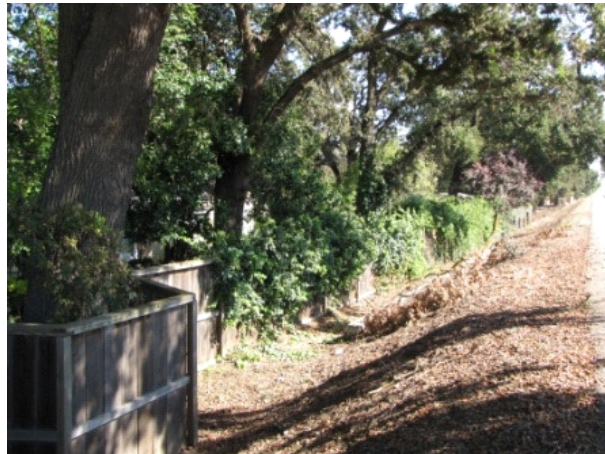
dpesaven_20091102_369.jpg

Levee Mile Report Line	50
Start Levee Mile	2.57
End Levee Mile	2.65
Location	Land Side
Category	Earthen Levee
Item	Encroachments

View of a wood fence adjacent to the landward toe looking upstream.

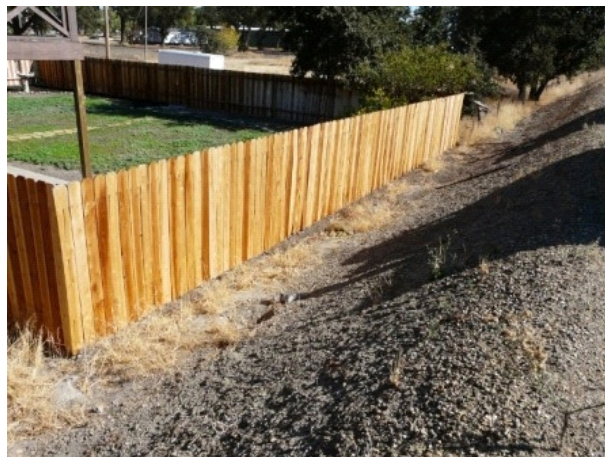
dpesaven_20091002_48.JPG

Levee Mile Report Line	51
Start Levee Mile	2.66
End Levee Mile	2.67
Location	Land Side
Category	Earthen Levee
Item	Encroachments

Newer fence built within landside toe of levee at from LM 2.66 to LM 2.67.

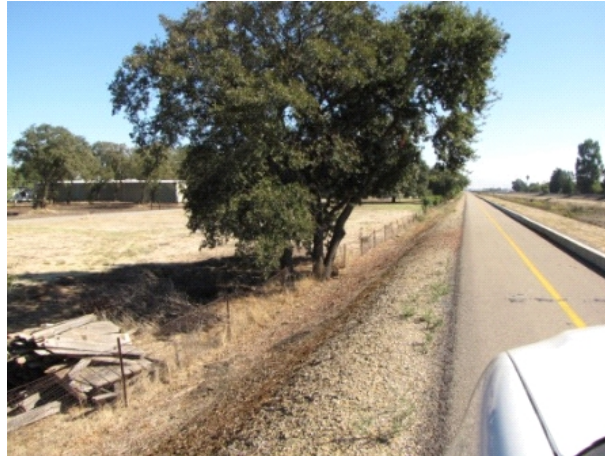
dpesaven_20091102_370.jpg

View of a metal fence adjacent to the landward toe looking upstream.

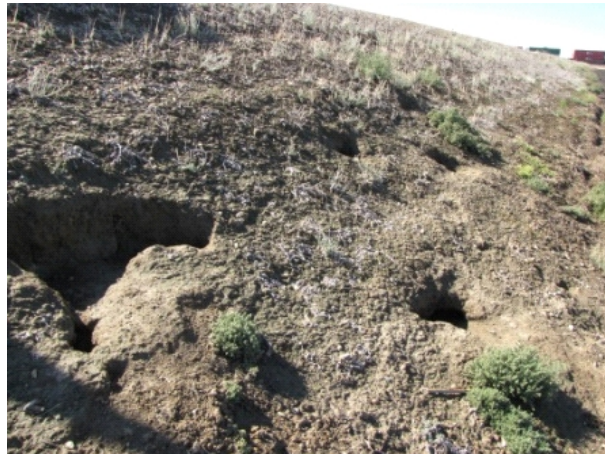
dpesaven_20091102_371.jpg

Levee Mile Report Line	54
Start Levee Mile	3.55
End Levee Mile	3.55
Location	Land Side
Category	Earthen Levee
Item	Animal Control

View of rodent holes in the landward slope.

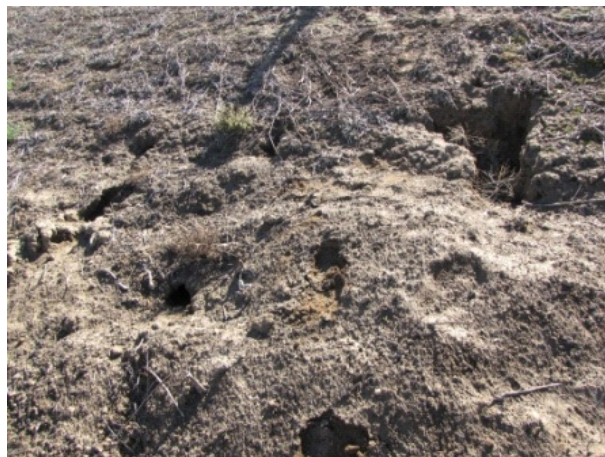
dpesaven_20091102_372.jpg

Levee Mile Report Line	55
Start Levee Mile	3.92
End Levee Mile	3.92
Location	Land Side
Category	Earthen Levee
Item	Animal Control

View of rodent holes in the landward slope.

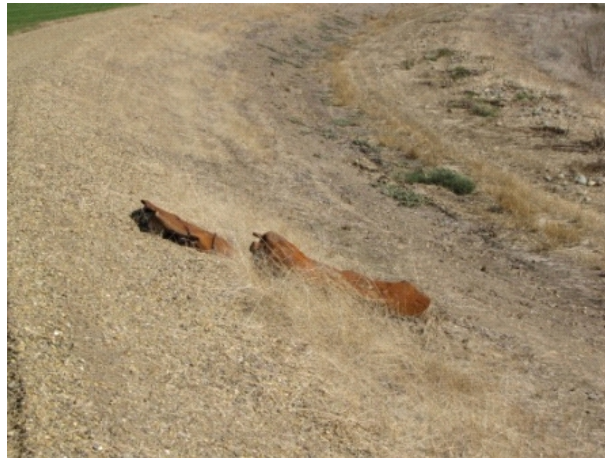
dpesaven_20091102_373.jpg

View of metal debris on the waterward slope looking upstream.

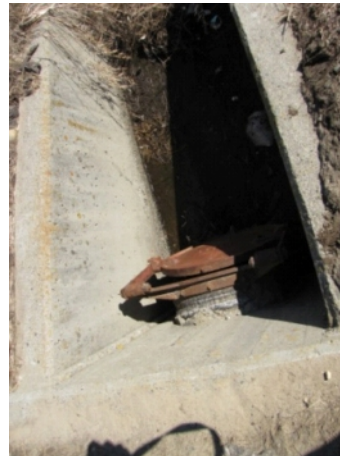
dpesaven_20091102_374.jpg

Levee Mile Report Line	58
Start Levee Mile	4.65
End Levee Mile	4.65
Location	Land Side
Category	Interior Drainage & Piping Systems
Item	Flap Gates

View of a flap gate unable to completely close due to debris in the pipe.

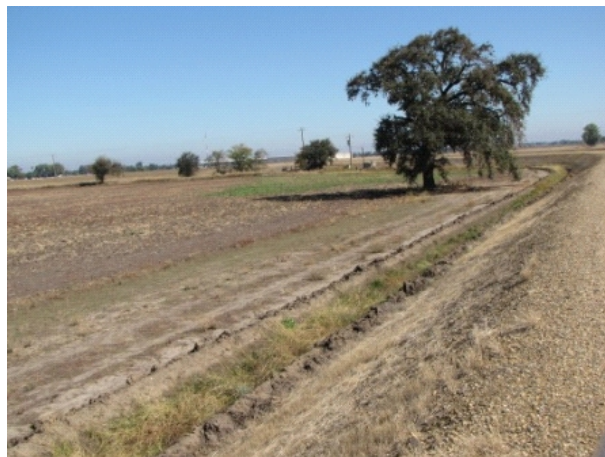
dpesaven_20091102_375.jpg

Levee Mile Report Line	59
Start Levee Mile	5.13
End Levee Mile	5.25
Location	Land Side
Category	Earthen Levee
Item	Encroachments

View of a ditch adjacent to the landward toe looking upstream.

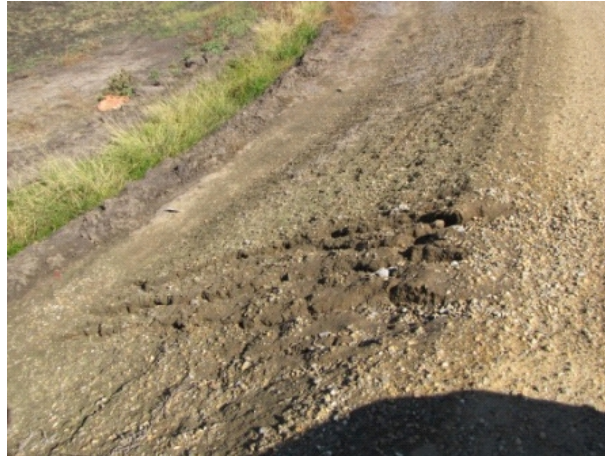
dpesaven_20091102_376.jpg

View of minor erosion on the landward shoulder and slope looking upstream.
